## General Information

| Make | Toyota | Model | Vios |
| YOM | 2024 | Mileage | 10,201 |
| Registration No. | NKC6788 | Chassis No. | PA1B18F34R4254892 |

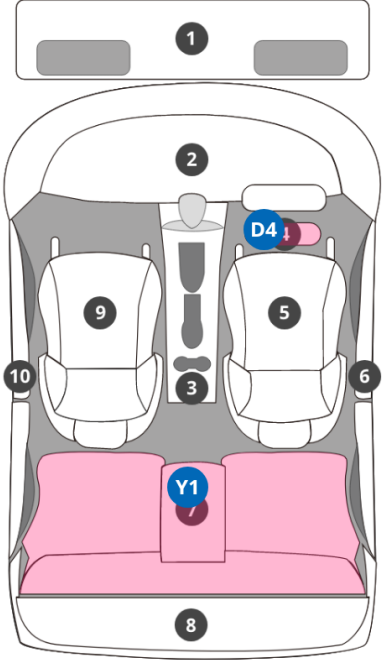
| Interior Evaluation : <span style="color: red;">C</span> | Exterior Evaluation : <span style="color: red;">C</span> |
| <b>Remarks</b><br>(L) Front Floor Mat - Worked - Large / Rear Seat - Grime - Minimal | <b>Remarks</b><br>Front Bumper, Grille, Lamps - Scratch & Dent - Large / (R) Rear Door, Molding - Dent - Small / (R) Front Door, Molding - Dent - Small / Rear Bumper, Lamps, Panels - Scratch - Small / Trunk Hood, Rear Gate - Scratch - Small / (L) Rear Fender, Molding - Scratch & Dent - Medium / (L) Front Door, Molding - Scratch - Small / Bonnet, Headlight - Scratch - Large / Roof - Dent - Small |
