## General Information

| Make | Toyota | Model | Vios |
| YOM | 2024 | Mileage | 33,248 |
| Registration No. | DBM2592 | Chassis No. | PA1B18F38R4239988 |

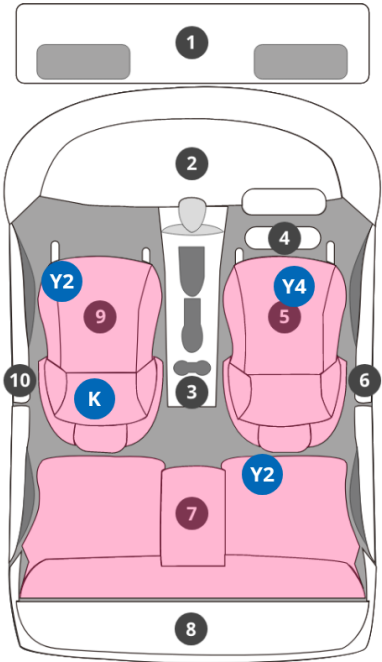
| Interior Evaluation : <span style="color: red;">C</span> | Exterior Evaluation : <span style="color: red;">C</span> |
|---|---|
| <b>Remarks</b><br>(R) Front Seat - Grime - Large / (L) Front Seat - Grime - Small / Overall Interior - Animal Hair - Yes / Rear Seat - Grime - Small | <b>Remarks</b><br>Bonnet, Headlight - Dent - Small / Front Bumper, Grille, Lamps - Scratch - Large / (R) Step, In-panel, Side Spoiler - Scratch & Dent - Medium / (R) Rear Fender, Molding - Scratch - Medium / Roof - Dent - Small / Rear Bumper, Lamps, Panels - Scratch - Minimal / Trunk Hood, Rear Gate - Crack, Gap - Small |

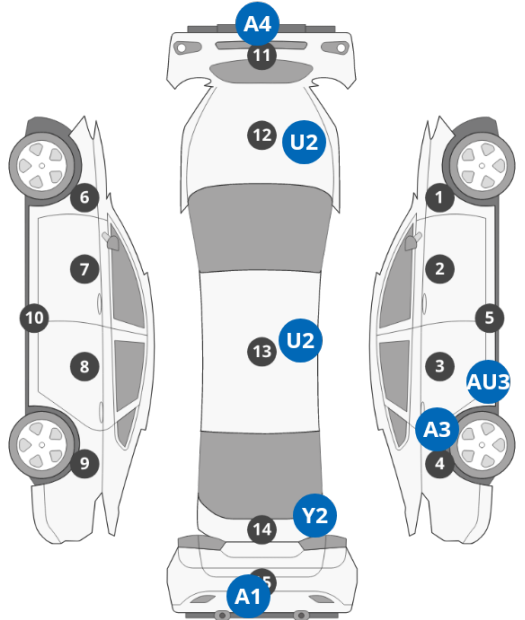
| Inspector Notes |
|---|
| paint cement splatter on the vehicle/ worn tires / incomplete tools/ with jack and spare tire/ with LTO plate/ power steering issue due to weak battery / slight bending o the front cross member support |
