## General Information

| Make | Toyota | Model | Vios |

## Body / Panel Condition

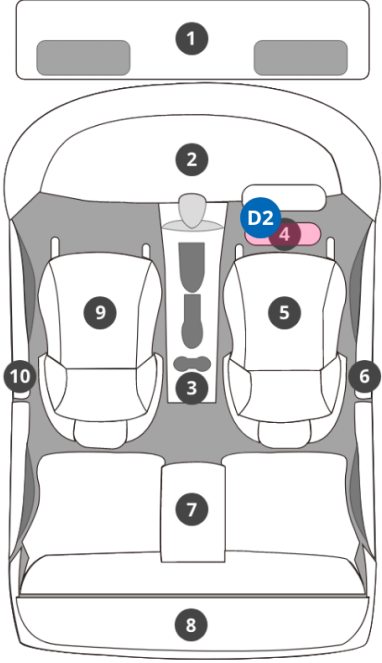
| <b>Remarks</b><br>(L) Front Floor Mat - Worked - Small | <b>Remarks</b><br>Bonnet, Headlight - Scratch & Dent - Medium / Rear Bumper, Lamps, Panels - Scratch - Large / Trunk Hood, Rear Gate - Crack, Gap - Large / (R) Rear Fender, Molding - Scratch - Small / (R) Front Door, Molding - Scratch & Dent - Medium / (R) Front Fender, Molding - Scratch & Dent - Medium / Front Bumper, Grille, Lamps - Scratch - Medium / (R) Front Wheel, Cover - Scratch, Corrosion - Small |
