## General Information

| Make | Toyota | Model | Avanza |
| Registration No. | NIO1767 | Chassis No. | MHFAB1BYXP3062770 |

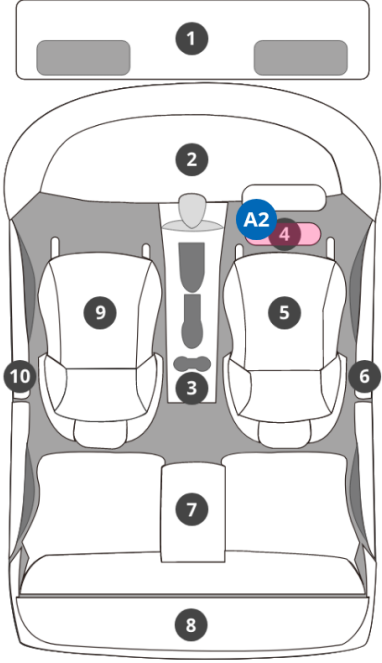
| <b>Interior Evaluation :</b> <span style="color: red; font-weight: bold;">A</span> | <b>Exterior Evaluation :</b> <span style="color: red; font-weight: bold;">D</span> |
| <b>Remarks</b><br>(L) Front Floor Mat - Cut, Crack - Small | <b>Remarks</b><br>(R) Rear Door, Molding - Dent - Small / (R) Step, In-panel, Side Spoiler - Scratch & Dent - Large / Front Bumper, Grille, Lamps - Scratch & Dent - Large / (L) Front Fender, Molding - Scratch - Small / (L) Front Door, Molding - Scratch - Large / (L) Rear Door, Molding - Scratch - Small / (L) Rear Fender, Molding - Scratch - Medium / Rear Bumper, Lamps, Panels - Scratch - Medium / Trunk Hood, Rear Gate - Scratch - Small |
