## General Information

| Make | Mazda | Model | CX-9 |
| YOM | 2023 | Odo Meter Reading | 70,773 |
| Registration No. | NFA8013 | Chassis No. | JM7TC4WLAR0477522 |

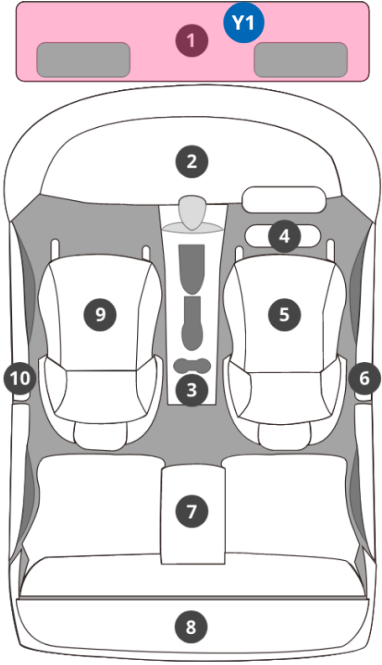
| Interior Evaluation : <span style="color: red;">A</span> | Exterior Evaluation : <span style="color: red;">B</span> |
|---|---|
| <b>Remarks</b><br>Ceiling - Grime - Minimal | <b>Remarks</b><br>Bonnet - Repair Traces - Yes / (R) Front Door, Molding - Scratch - Small / (L) Rear Door, Molding - Scratch - Small / (R) Front Fender, Molding - Scratch - Minimal / Trunk Hood, Rear Gate - Scratch - Small / Rear Bumper, Lamps, Panels - Scratch - Minimal / Roof - Scratch - Small |

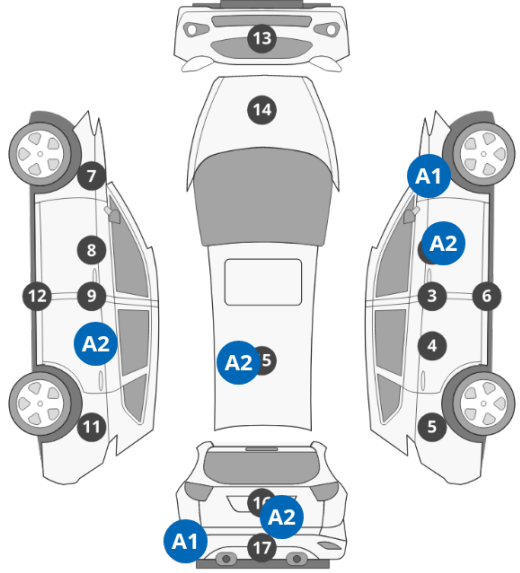
| Inspector Notes |
|---|
| with LTO plate and Jack, Spare tire and incomplete tools. no warranty booklet and scratch headlight and tail light. |
