## General Information

| Make | Toyota | Model | Vios |
| YOM | 2024 | Mileage | 6,994 |
| Registration No. | DBO5754 | Chassis No. | PA1B18F3XP4238659 |

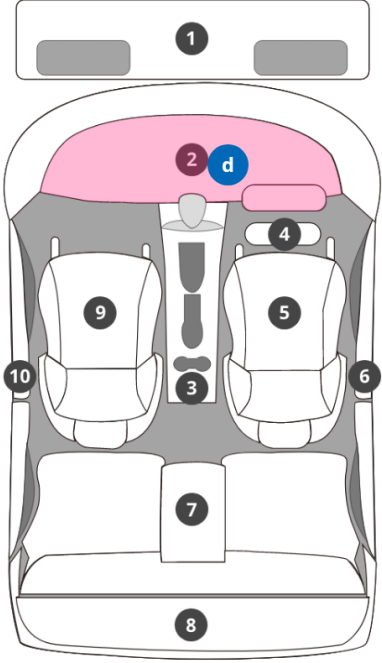
| Interior Evaluation : <span style="color: red; font-weight: bold;">A</span> | Exterior Evaluation : <span style="color: red; font-weight: bold;">B</span> |
| <b>Remarks</b><br>Dashboard - Traces of Adhesive Tape - Yes | <b>Remarks</b><br>Front Bumper, Grille, Lamps - Scratch - Small / (R) Mirror - Faded(Color, Gloss) - Yes / (R) Front Door, Molding - Scratch - Minimal / (R) Rear Door, Molding - Scratch - Minimal / (R) Rear Fender, Molding - Scratch - Minimal / Trunk Hood, Rear Gate - Scratch - Minimal / Rear Bumper, Lamps, Panels - Scratch - Minimal / Bonnet, Headlight - Scratch - Minimal / (R) Front Fender, Molding - Scratch - Medium |

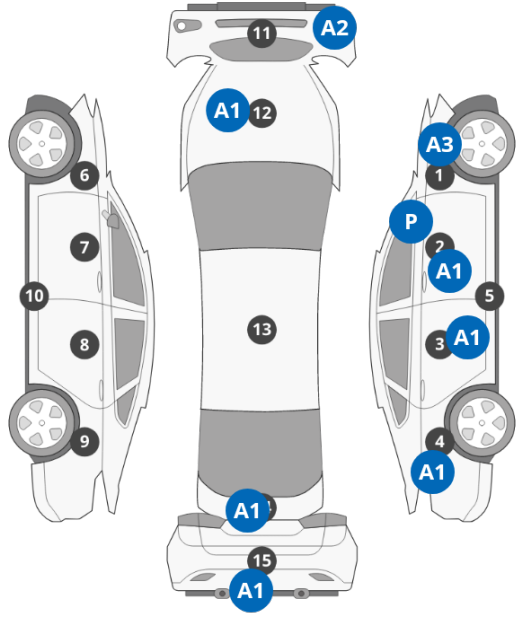
hairlines scratches/with spare tire & tool & warranty booklet
