## General Information

| Make | Toyota | Model | Vios |

## Body / Panel Condition

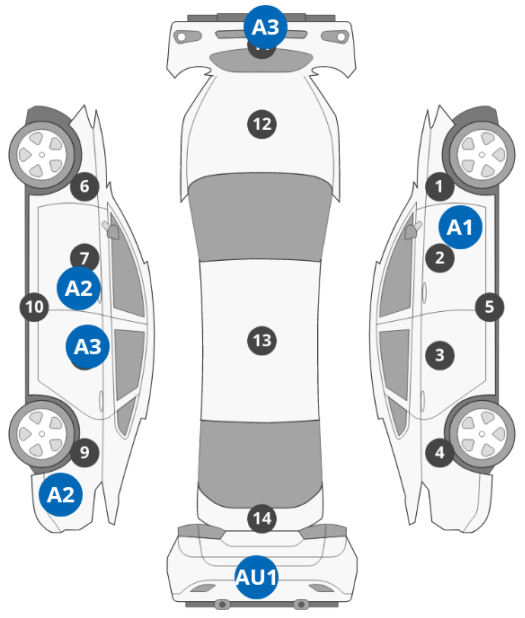
| Interior Evaluation : <b>A</b> | Exterior Evaluation : <b>B</b> |
| <b>Remarks</b><br>Defects not found | <b>Remarks</b><br>(L) Front Door, Molding - Scratch - Small / (L) Rear Door, Molding - Scratch - Medium / (L) Rear Fender, Molding - Scratch - Small / Rear Bumper, Lamps, Panels - Scratch & Dent - Minimal / (R) Front Door, Molding - Scratch - Minimal / Front Bumper, Grille, Lamps - Scratch - Medium |

swirlmarks and hairline scratches around the exterior. with warranty booklet and user manual. trunk floor mat missing.
