General Information

Make	Toyota	Model	Vios
YOM	2024	Mileage	7,447
Registration No.	NHQ6814	Chassis No.	PA1B18F34R4253516
CC	1.3	Transmission	CVT
Fuel Type	Gas	Type of Body	Sedan
Colour	Blue

Body / Panel Condition

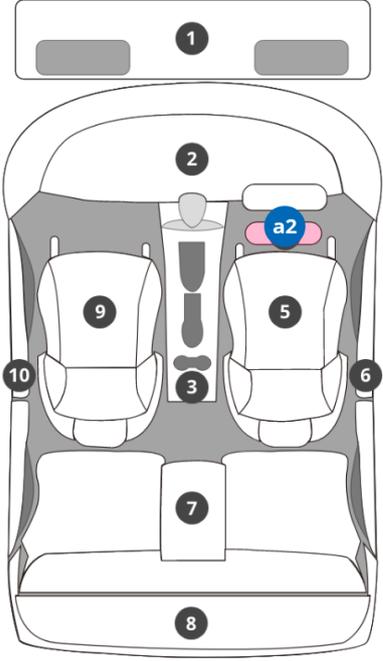
<p>a : Cut, Fray d : Loose, Deformed k : Animal Hair s : Smell t : Cigarette Burns x : Defective y : Stain</p>

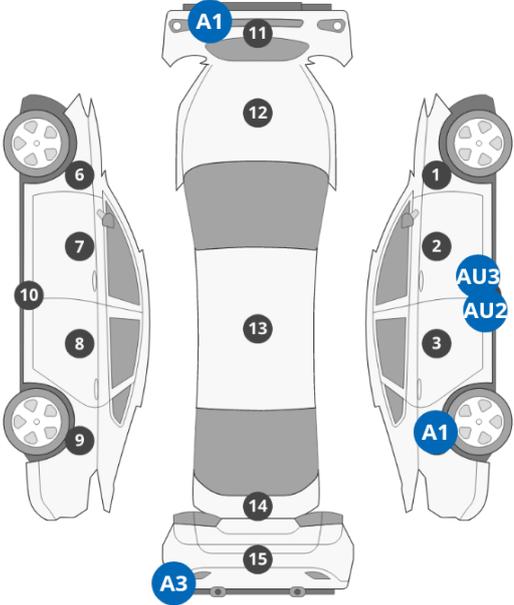
<p>A : Scratch AU : Scratch & Dent B : Modified C : Corrosion G : Stone chip P : Faded S : Rust SC : Rust & Corrosion U : Dent X : Defective Y : Crack, Gap</p>
<p>Remarks (L) Front Floor Mat - Cut, Crack - Small</p>	<p>Remarks (R) Front Door, Molding - Scratch & Dent - Medium / (R) Rear Door, Molding - Scratch & Dent - Small / Rear Bumper, Lamps, Panels - Scratch - Medium / Front Bumper, Grille, Lamps - Scratch - Minimal / (R) Rear Fender, Molding - Scratch - Minimal</p>
Frame Evaluation : A	Functional Evaluation : A
<p>Remarks Defects not found</p>	<p>Remarks Defects not found</p>

<p>Inspector Notes</p>
<p>hairline scratches around the exterior. Adhesive marks at the right door panels. with user manual and warranty booklet. incomplete tools.</p>
