## General Information

| Make | Toyota | Model | Veloz |

## Body / Panel Condition

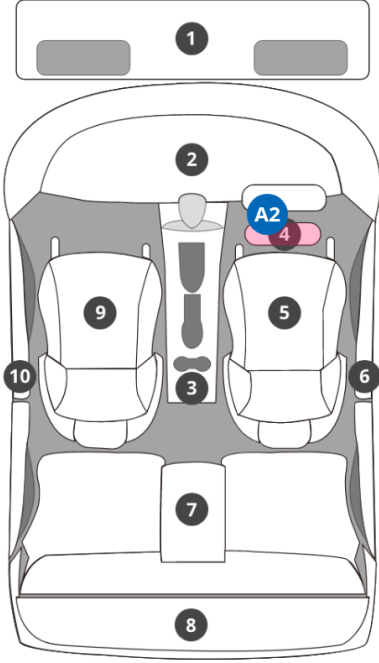
| Interior Evaluation : <span style="color: red;">A</span> | Exterior Evaluation : <span style="color: red;">C</span> |
| <b>Remarks</b><br>(L) Front Floor Mat - Cut, Crack - Small | <b>Remarks</b><br>(R) Rear Door, Molding - Scratch - Medium / (R) Rear Fender, Molding - Scratch - Medium / Front Bumper, Grille, Lamps - Scratch - Medium / (L) Front Door, Molding - Scratch - Medium / (L) Rear Door, Molding - Scratch - Medium / (L) Rear Fender, Molding - Scratch - Medium / Rear Bumper, Lamps, Panels - Scratch & Dent - Medium / Trunk Hood, Rear Gate - Scratch - Small |
