## General Information

| Make | Toyota | Model | Vios |
| Registration No. | CBI1269 | Chassis No. | PA1B18F31P4207185 |

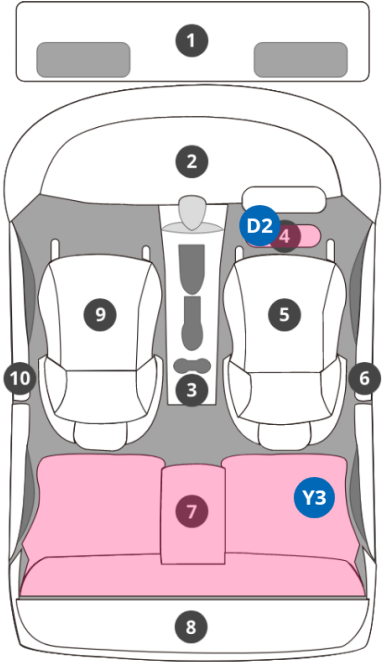
| Interior Evaluation : <b>B</b> | Exterior Evaluation : <b>B</b> |
| <b>Remarks</b><br>Rear Seat - Grime - Medium / (L) Front Floor Mat - Worked - Small | <b>Remarks</b><br>(R) Step - Repair Traces - Yes / (L) Front Fender - Repair Traces - Yes / (L) Rear Fender, Molding - Dent - Minimal / Front Bumper, Grille, Lamps - Dent - Small / (R) Front Fender, Molding - Scratch - Small / (R) Front Door, Molding - Scratch - Small / (R) Rear Door, Molding - Scratch - Small / (R) Rear Fender, Molding - Repair mark - Yes / (L) Front Door, Molding - Dent - Small / (L) Step, In-panel, Side Spoiler - Scratch - Small |
