## General Information

| Make | Toyota | Model | Vios |
| YOM | 2023 | Mileage | 46,802 |

## Body / Panel Condition

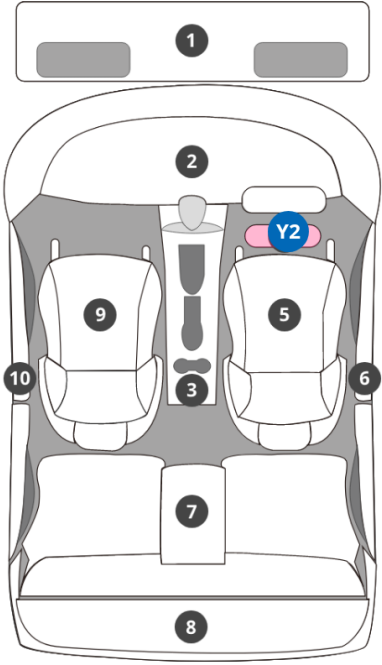
| Interior Evaluation : <span style="color: red;">A</span> | Exterior Evaluation : <span style="color: red;">C</span> |
| <b>Remarks</b><br>(R) Front Floor Mat - Grime - Small | <b>Remarks</b><br>(R) Step, In-panel, Side Spoiler - Scratch & Dent - Large / (R) Front Door, Molding - Scratch - Medium / (R) Rear Fender, Molding - Scratch - Medium / Front Bumper, Grille, Lamps - Scratch - Large / Rear Bumper, Lamps, Panels - Scratch - Medium / (L) Rear Fender, Molding - Scratch - Small / (L) Rear Door, Molding - Scratch - Small |
