## General Information

| Make | Toyota | Model | Vios |

## Body / Panel Condition

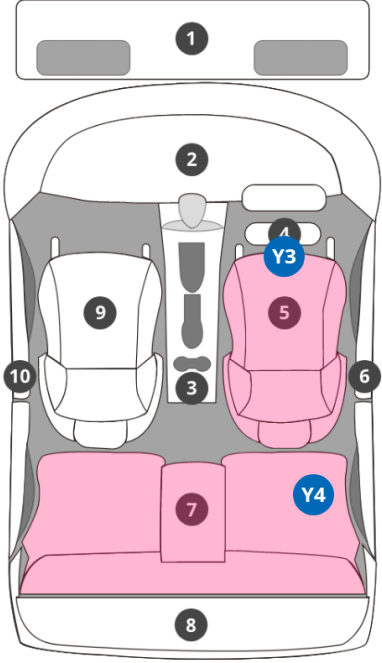
| Interior Evaluation : <span style="color: red;">C</span> | Exterior Evaluation : <span style="color: red;">C</span> |
| <b>Remarks</b><br>Rear Seat - Grime - Large / (R) Front Seat - Grime - Medium | <b>Remarks</b><br>Front Bumper, Grille, Lamps - Scratch - Medium / (R) Rear Door, Molding - Dent - Medium / Rear Bumper, Lamps, Panels - Scratch - Small / (L) Rear Fender, Molding - Scratch & Dent - Medium / (L) Rear Door, Molding - Dent - Medium / Bonnet, Headlight - Scratch - Medium / (L) Mirror - Scratch - Minimal / (R) Mirror - Scratch - Small |
