## General Information

| Make | Toyota | Model | Wigo |
| YOM | 2022 | Mileage | 48,178 |
| Registration No. | EAE5206 | Chassis No. | MHKA4DF5FMJ061304 |

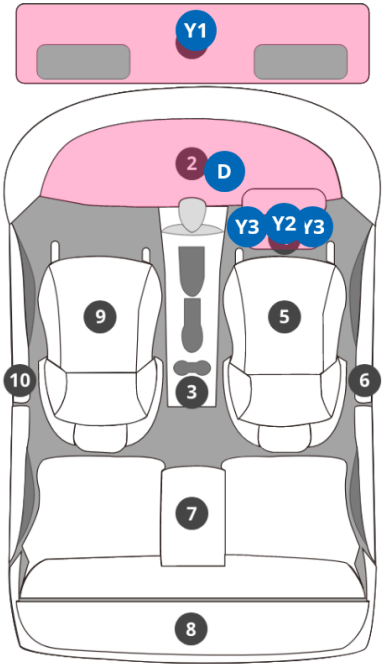
| <b>Interior Evaluation :</b> <span style="color: red; font-weight: bold;">B</span> | <b>Exterior Evaluation :</b> <span style="color: red; font-weight: bold;">C</span> |
| <b>Remarks</b><br>Ceiling - Grime - Minimal / Dashboard - Traces of Adhesive Tape - Yes / (R) Front Floor Mat - Grime - Medium / Mat Other - Grime - Small / (L) Front Floor Mat - Grime - Medium | <b>Remarks</b><br>Front Bumper, Grille, Lamps - Scratch & Dent - Medium / (R) Mirror - Scratch - Small / (R) Front Door, Molding - Scratch - Medium / (R) Rear Door, Molding - Scratch - Large / Roof - Scratch & Dent - Medium / Rear Bumper, Lamps, Panels - Scratch - Small / (L) Mirror - Scratch - Small / (L) Front Door, Molding - Scratch - Large |
