## General Information

| Make | Toyota | Model | Vios |

## Body / Panel Condition

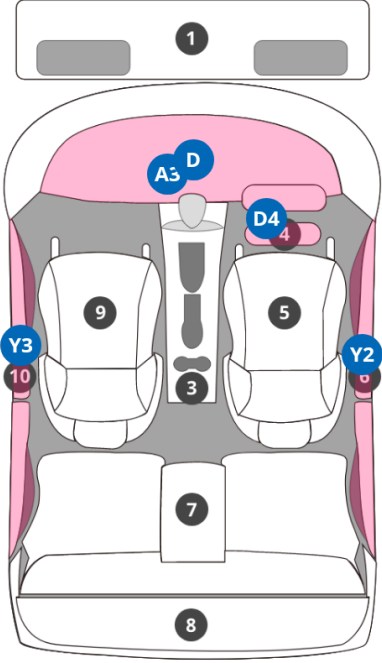
| Interior Evaluation : <span style="color: red;">C</span> | Exterior Evaluation : <span style="color: red;">B</span> |
| <p><b>Remarks</b><br/>(R) Front Trim - Grime - Small / (L) Front Floor Mat - Worked - Large / (L) Front Trim - Grime - Medium / Dashboard - Worn, Scratch, Cut, Crack - Medium / Dashboard - Traces of Adhesive Tape - Yes</p> | <p><b>Remarks</b><br/>(R) Front Fender - Repair Traces - Yes / (R) Front Door, Molding - Scratch - Small / Rear Bumper, Lamps, Panels - Scratch - Minimal / (L) Step, In-panel, Side Spoiler - Scratch &amp; Dent - Medium / Front Bumper, Grille, Lamps - Scratch - Medium / Roof Spoiler, Molding - Rust, Corrosion - Minimal</p> |
