## General Information

| Make | Toyota | Model | Vios |
| Registration No. | BAE9665 | Chassis No. | PA1B18F30M4163692 |

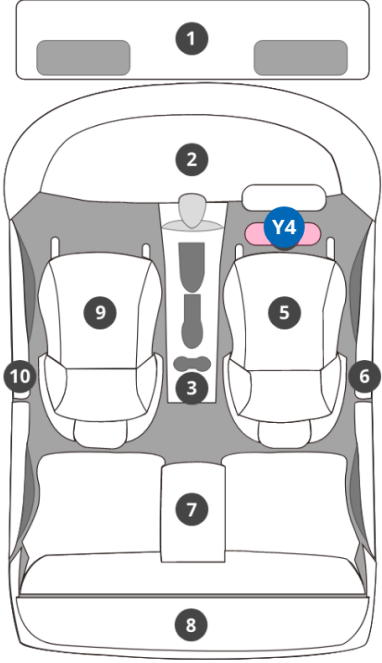
| Interior Evaluation : <span style="color: red;">C</span> | Exterior Evaluation : <span style="color: red;">C</span> |
| <b>Remarks</b><br>(L) Front Floor Mat - Grime - Large | <b>Remarks</b><br>Rear Bumper, Lamps, Panels - Scratch - Large / (L) Rear Fender, Molding - Dent - Small / (L) Rear Door, Molding - Dent - Small / (L) Front Door, Molding - Dent - Small / Front Bumper, Grille, Lamps - Scratch - Large / (R) Front Fender, Molding - Dent - Small / Bonnet, Headlight - Dent - Small / (R) Step, In-panel, Side Spoiler - Dent - Small / (R) Rear Door, Molding - Scratch & Dent - Medium / Trunk Hood, Rear Gate - Dent - Minimal |
