## General Information

| Make | Toyota | Model | Vios |

## Body / Panel Condition

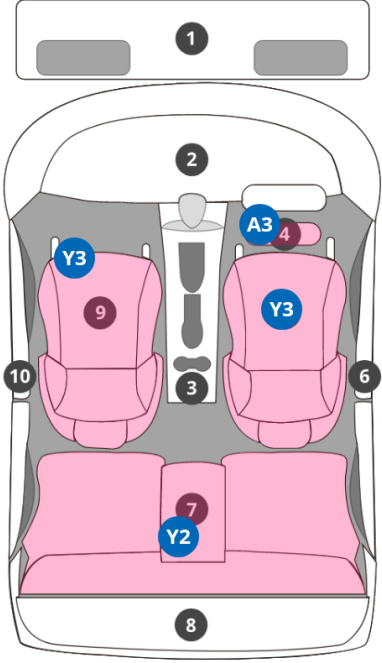
| <b>Remarks</b><br>(R) Front Seat - Grime - Medium / Rear Seat - Grime - Small / (L) Front Floor Mat - Cut, Crack - Medium / (L) Front Seat - Grime - Medium | <b>Remarks</b><br>(L) Rear Door - Repair Traces - Yes / (L) Rear Fender - Repair Traces - Yes / Rear Bumper, Lamps, Panels - Dent - Small / (L) Front Fender, Molding - Dent - Minimal |
