## General Information

| Make | Toyota | Model | Vios |

## Body / Panel Condition

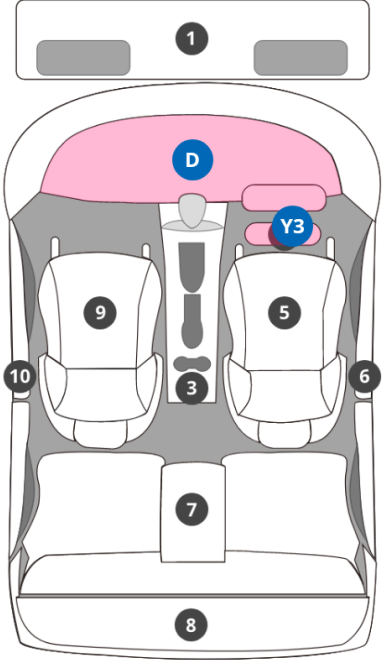
| Interior Evaluation : <b>B</b> | Exterior Evaluation : <b>B</b> |
|---|---|
| <b>Remarks</b><br>Dashboard - Traces of Adhesive Tape - Yes / (L) Front Floor Mat - Grime - Medium | <b>Remarks</b><br>Trunk Hood, Rear Gate - Dent - Minimal / (R) Front Door, Molding - Scratch - Small / Front Bumper, Grille, Lamps - Scratch - Medium / (R) Rear Fender, Molding - Scratch - Small / (R) Mirror - Scratch, Peeled - Minimal / (L) Rear Fender, Molding - Scratch - Small / Rear Bumper, Lamps, Panels - Scratch - Small |

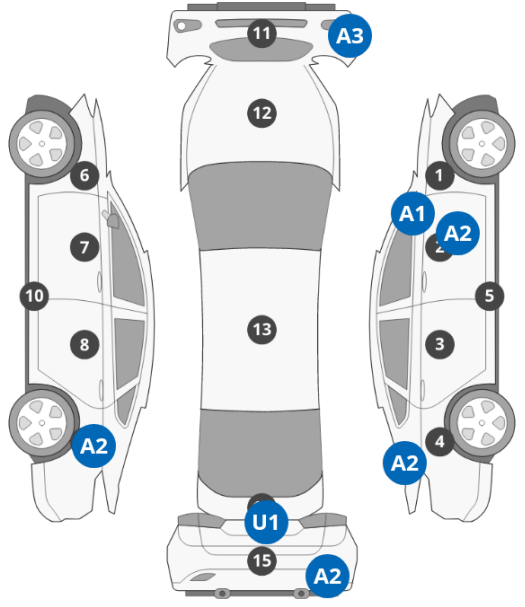
with LTO plate/with spare tire/jack and tools with warranty booklet/front bumper was re-painted
